**MONITORING RESULTS FROM THE FIELD PILOT STUDY
OF IN SITU CAPPING OF PALOS VERDES SHELF
CONTAMINATED SEDIMENTS
(Part 2 of 2)**

July 2002

Science Applications International Corporation
Admiral's Gate
221 Third Street
Newport, RI 02840
SAIC Report Number 514

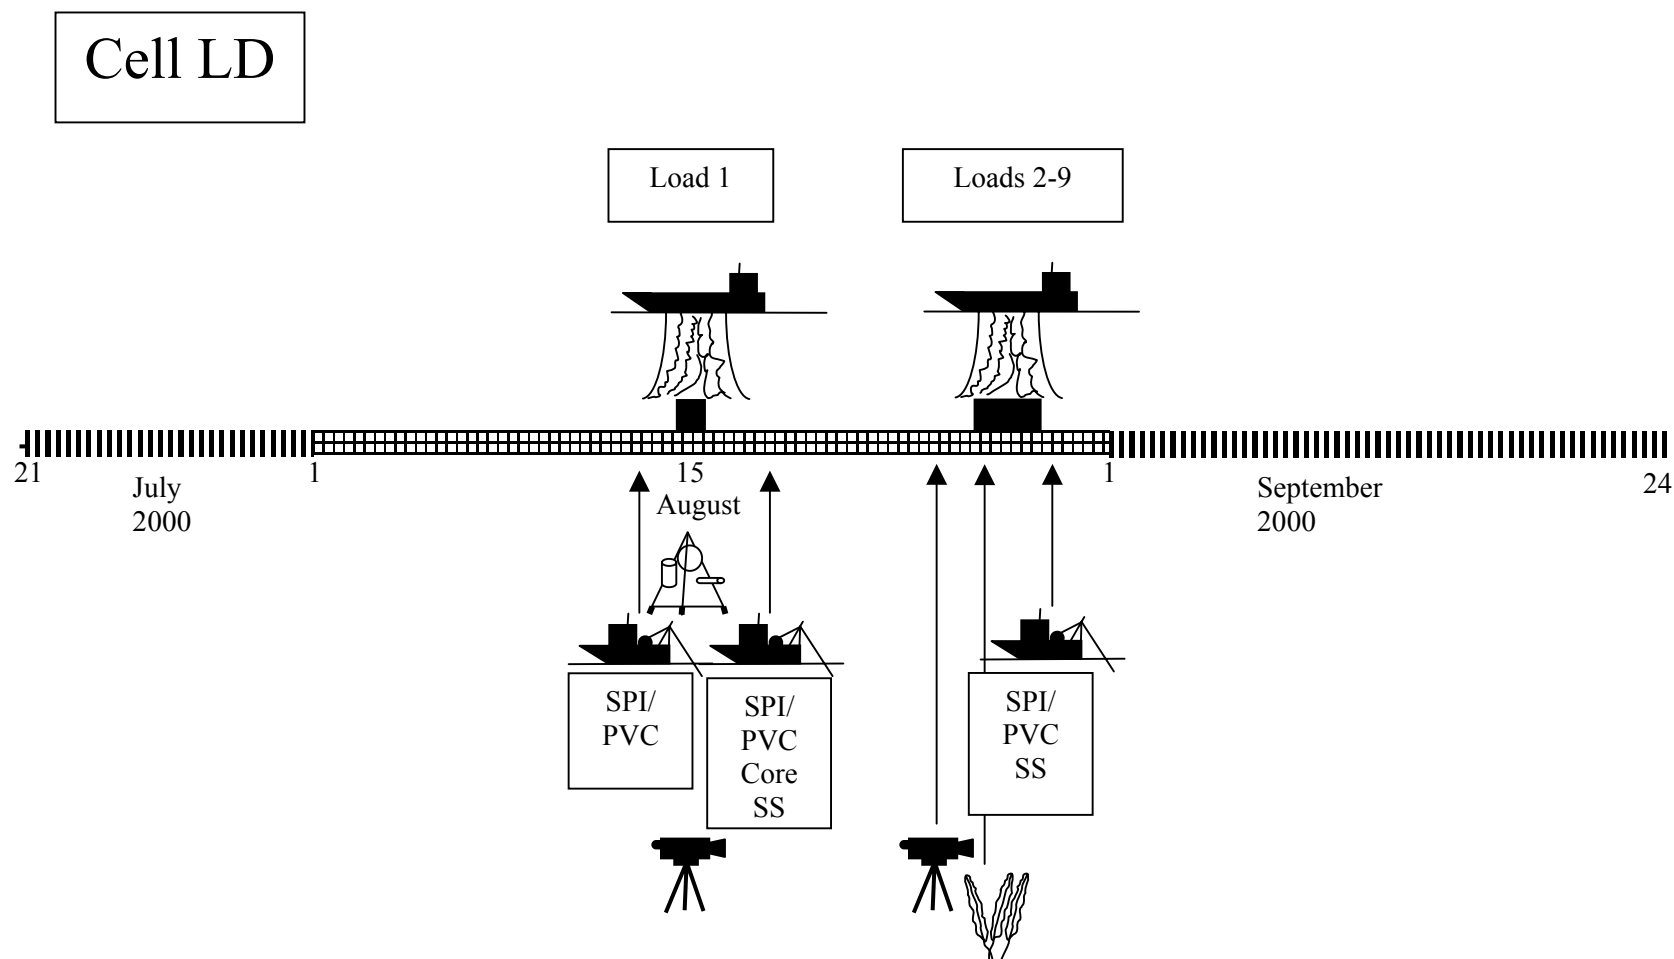
Figure 5.1-1. Activities timeline for Cell LD 21 July 2000-24 September 2000. Cap placement activities are indicated by the dredge symbol and solid bar. Monitoring activities are shown by the research vessel, current meter tripod, video camera, and kelp symbols. Monitoring activity codes associated with the research vessel symbol are SPI-Sediment Profile Imaging, PVC-Plan View Camera, Core-Coring survey, and SS-Side Scan.

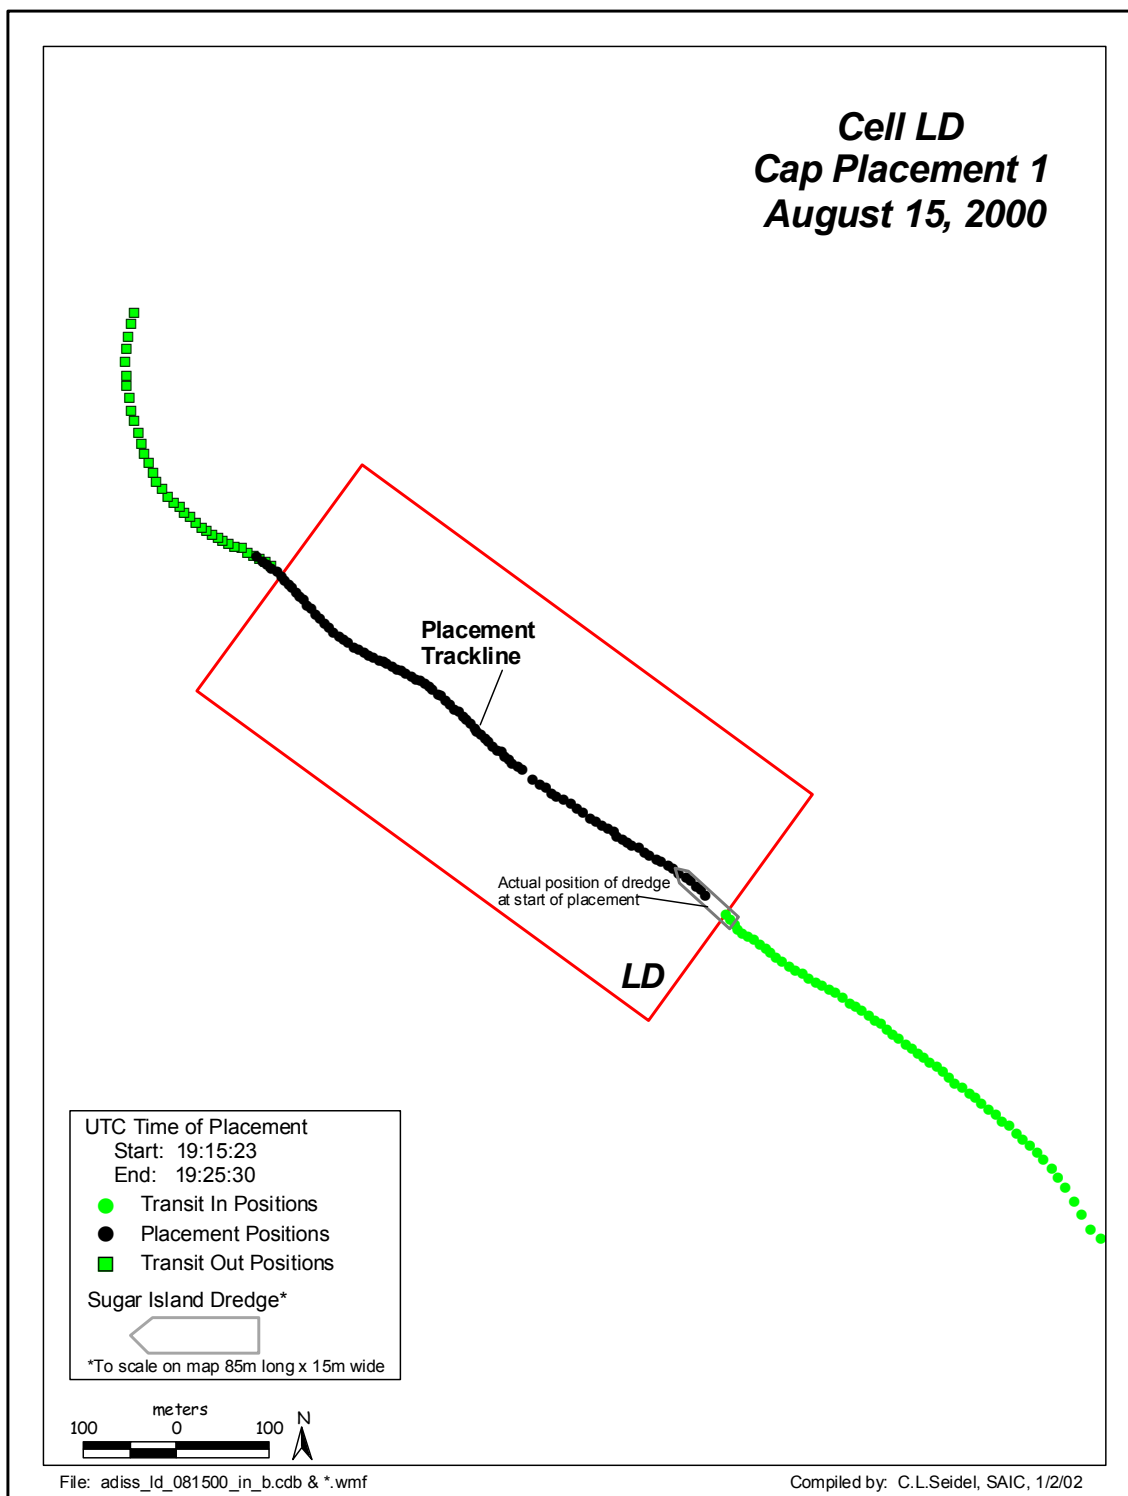
Figure 5.2-1. Map illustrating Cell LD on the Palos Verdes Shelf and the trackline of the hopper dredge *Sugar Island* as it traveled northwestward along the axis of the cell during spreading Event 1 on August 15, 2000. Dredge position data were acquired by ADISS.

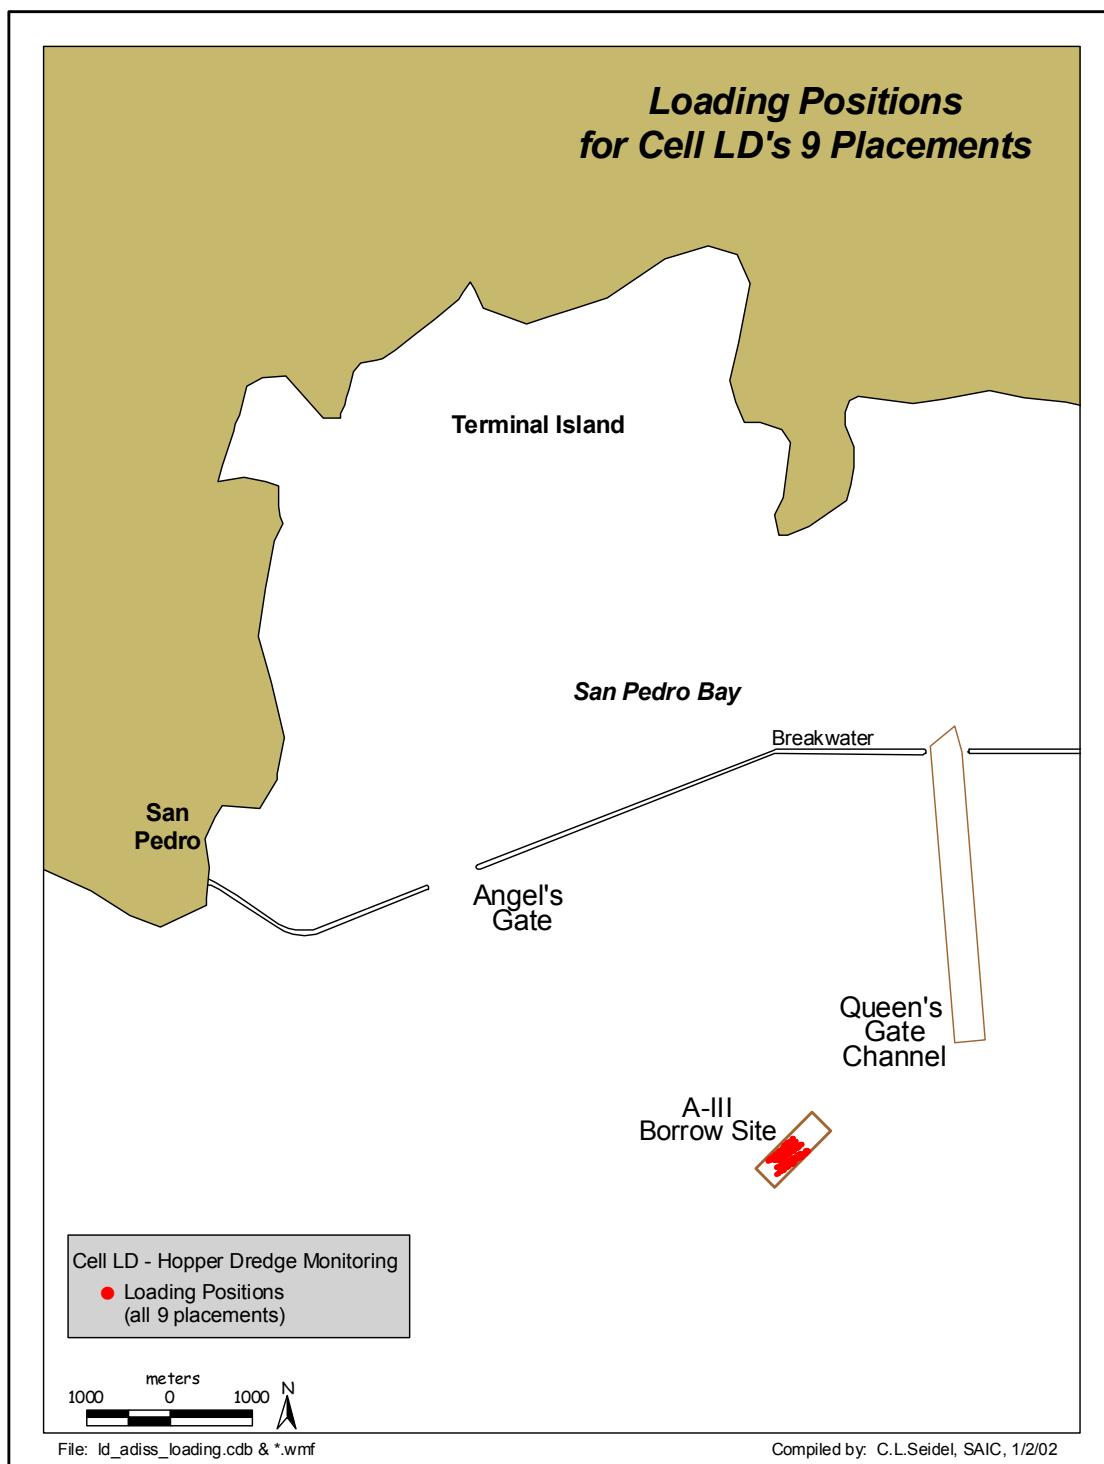
Figure 5.2-2. Map of Los Angeles/Long Beach Harbor region indicating the locations of the dredging within the A-III Borrow Area for material that was used for capping during Events 1 to 9 in Cell LD. Dredge position data were acquired by ADISS.

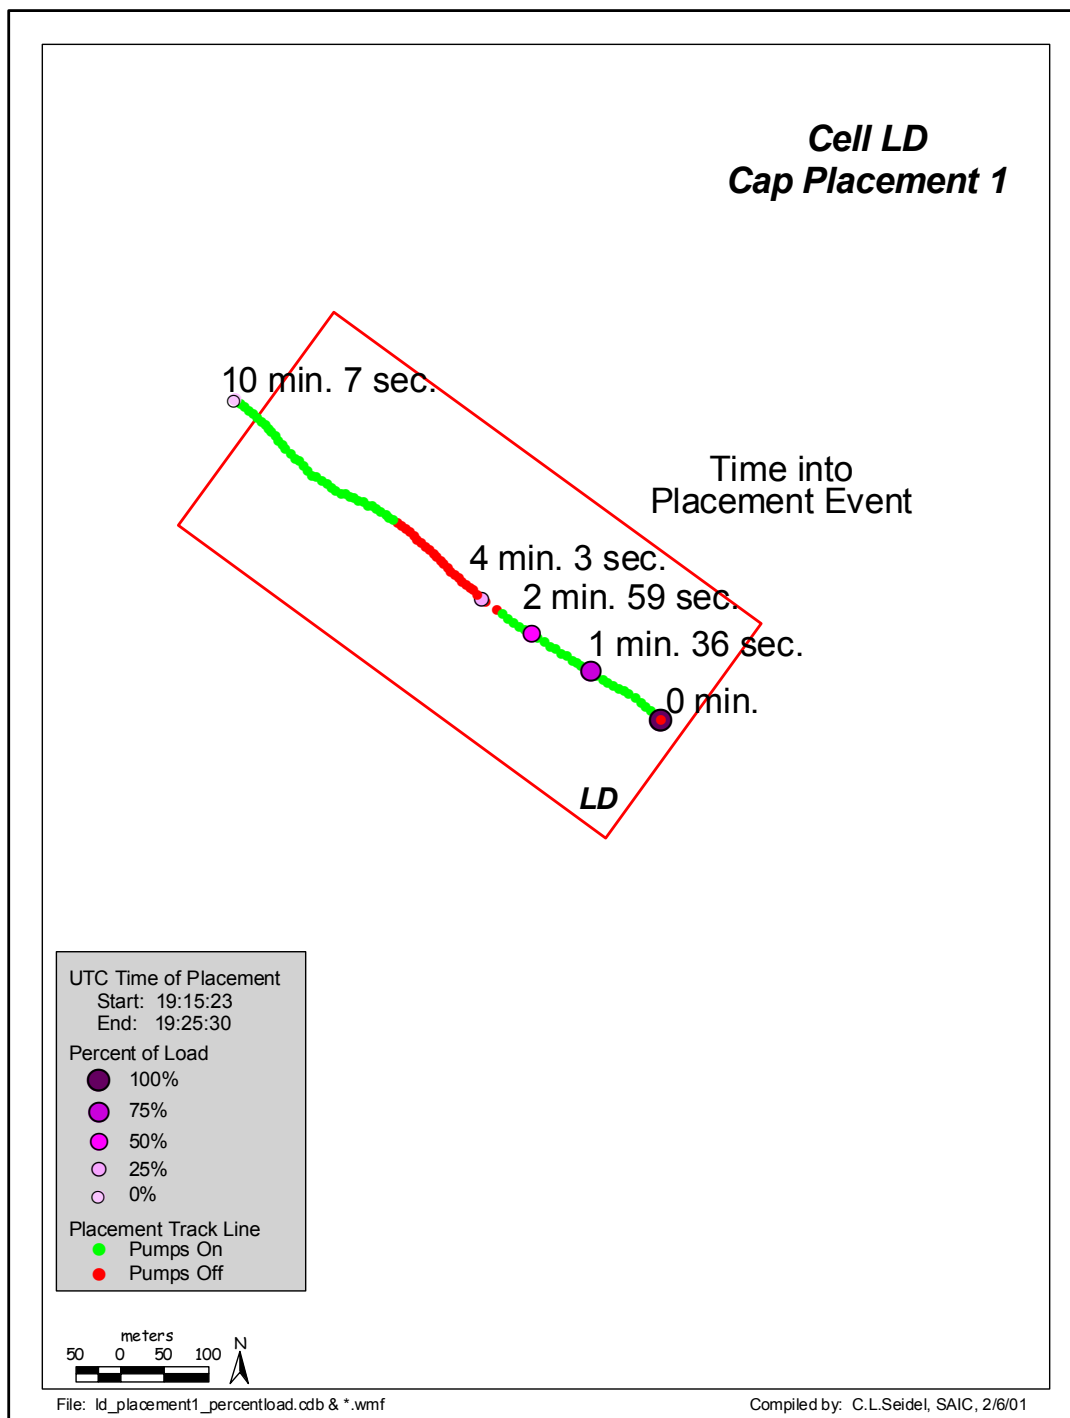
Figure 5.2-4. Map illustrating Cell LD on the Palos Verdes Shelf and positions of the hopper dredge *Sugar Island* as it moved northwestward during spreading of cap material during Event 1 on August 15, 2000. Dredge position data were acquired by ADISS. Also shown are the elapsed times that correspond with the percent of material (i.e., 100%, 75%, etc.) remaining within the hopper.

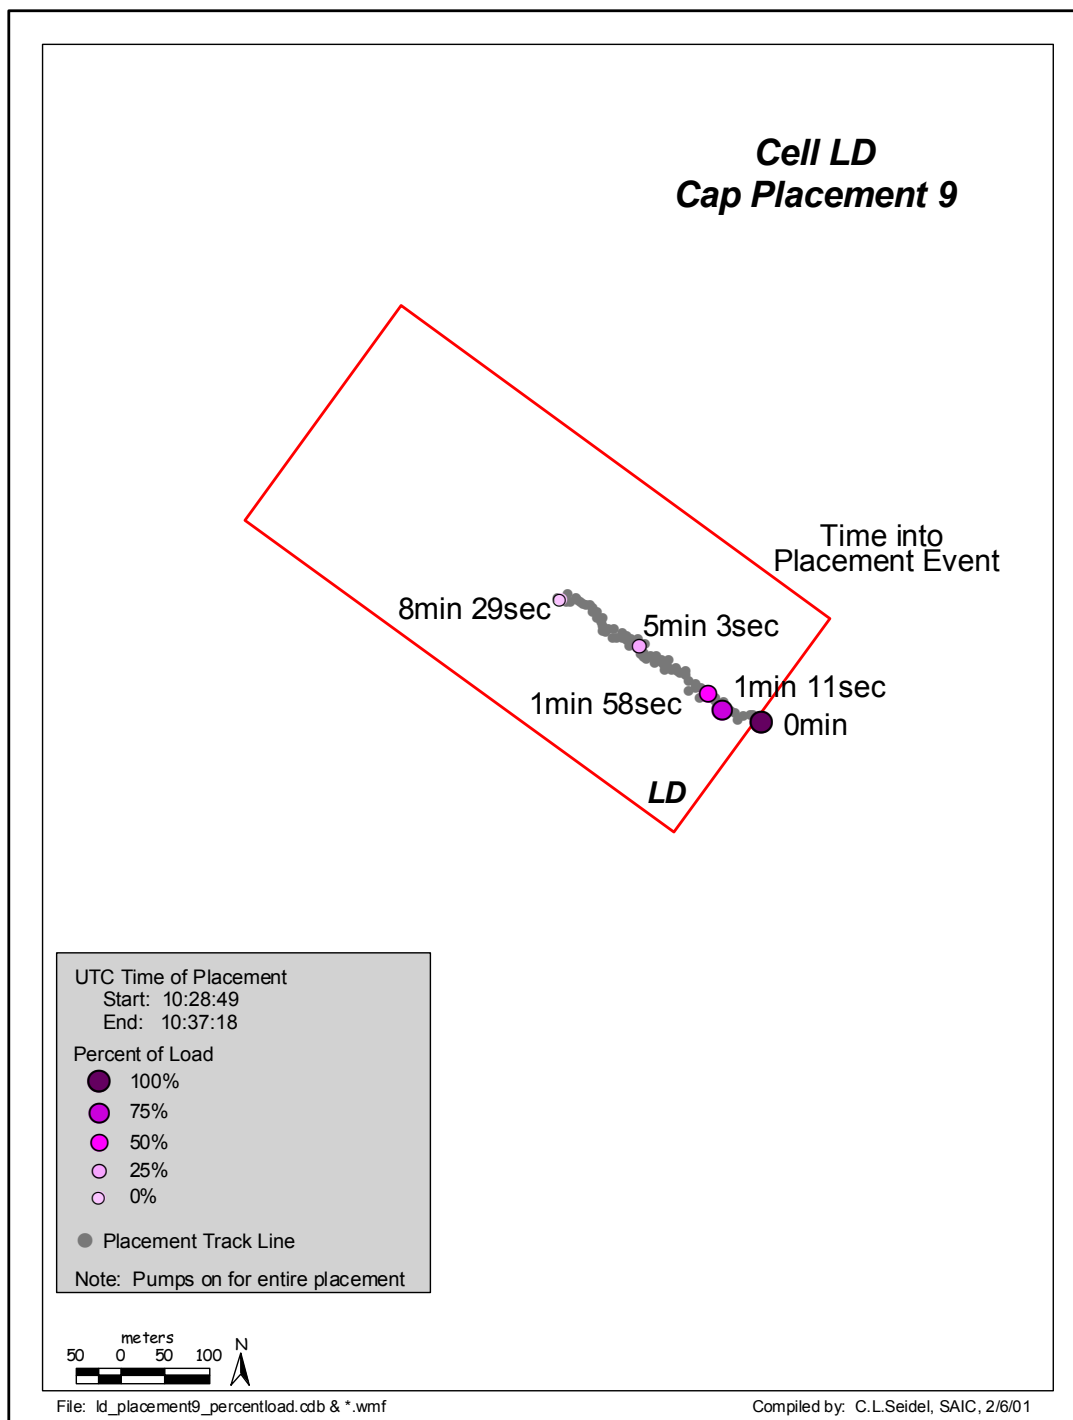
Figure 5.2-5. Map illustrating Cell LD on the Palos Verdes Shelf and positions of the hopper dredge *Sugar Island* as it moved northwestward during spreading of cap material during Event 9 on August 30, 2000. Dredge position data were acquired by ADISS. Also shown are the elapsed times that correspond with the percent of material (i.e., 100%, 75%, etc.) remaining within the hopper.

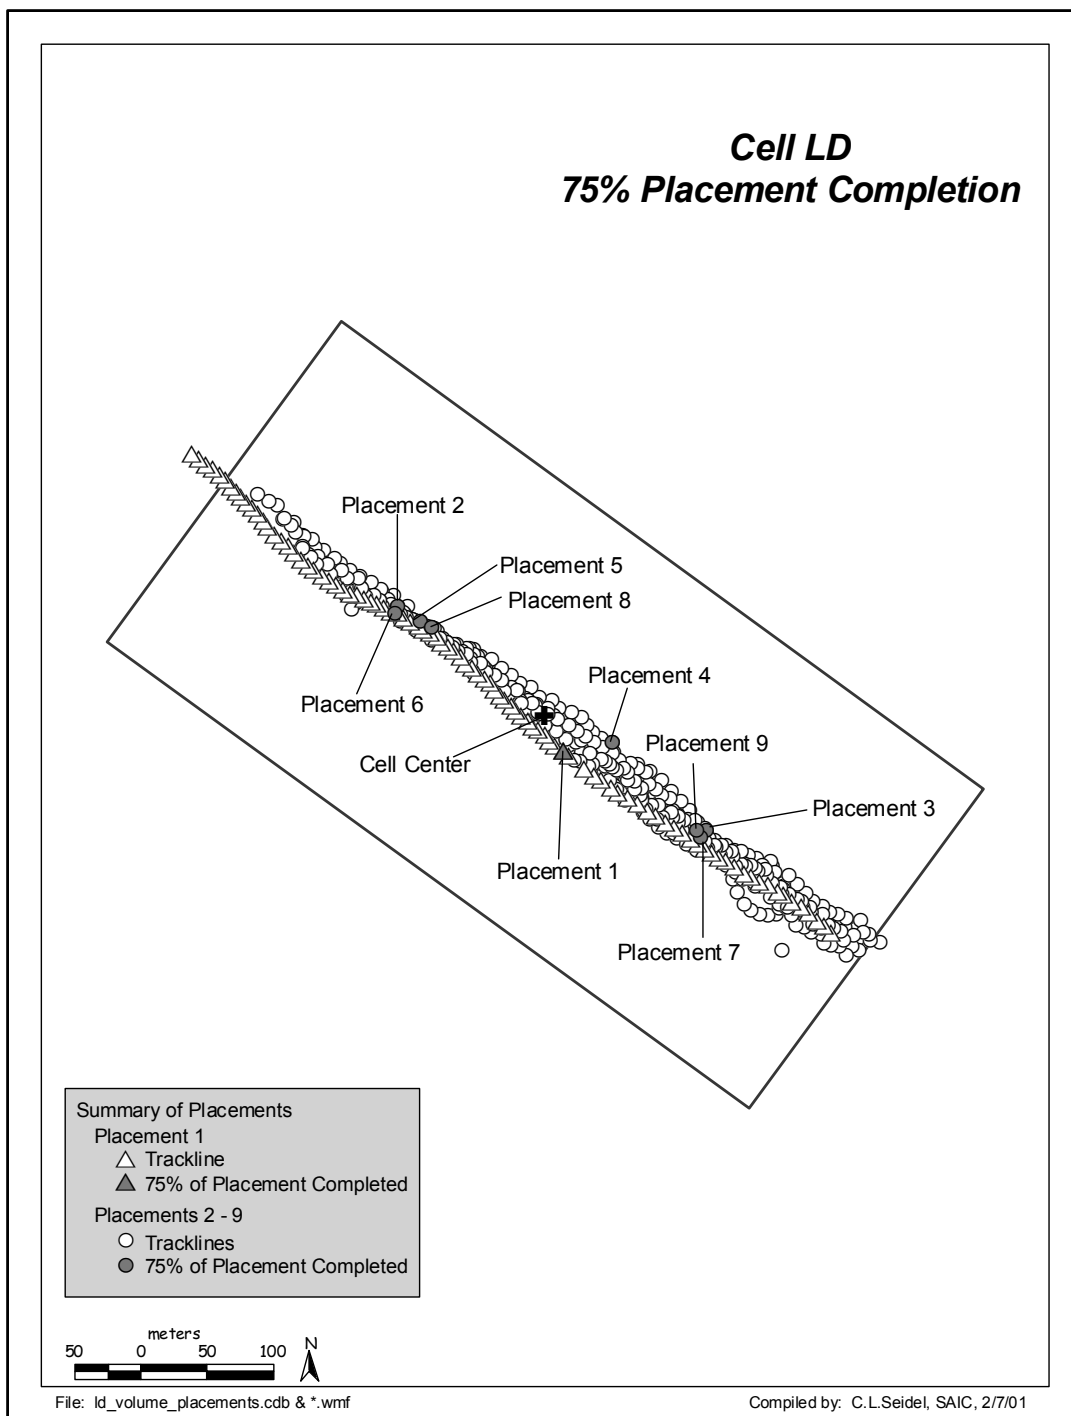
Figure 5.2-6. Map illustrating Cell LD on the Palos Verdes Shelf and positions of the hopper dredge *Sugar Island* as it moved northwestward during spreading of cap material during Events 1 to 9 in August 2000. Dredge position data were acquired by ADISS. Also shown are the positions where 75% of the hopper volume had been released during each spreading event.

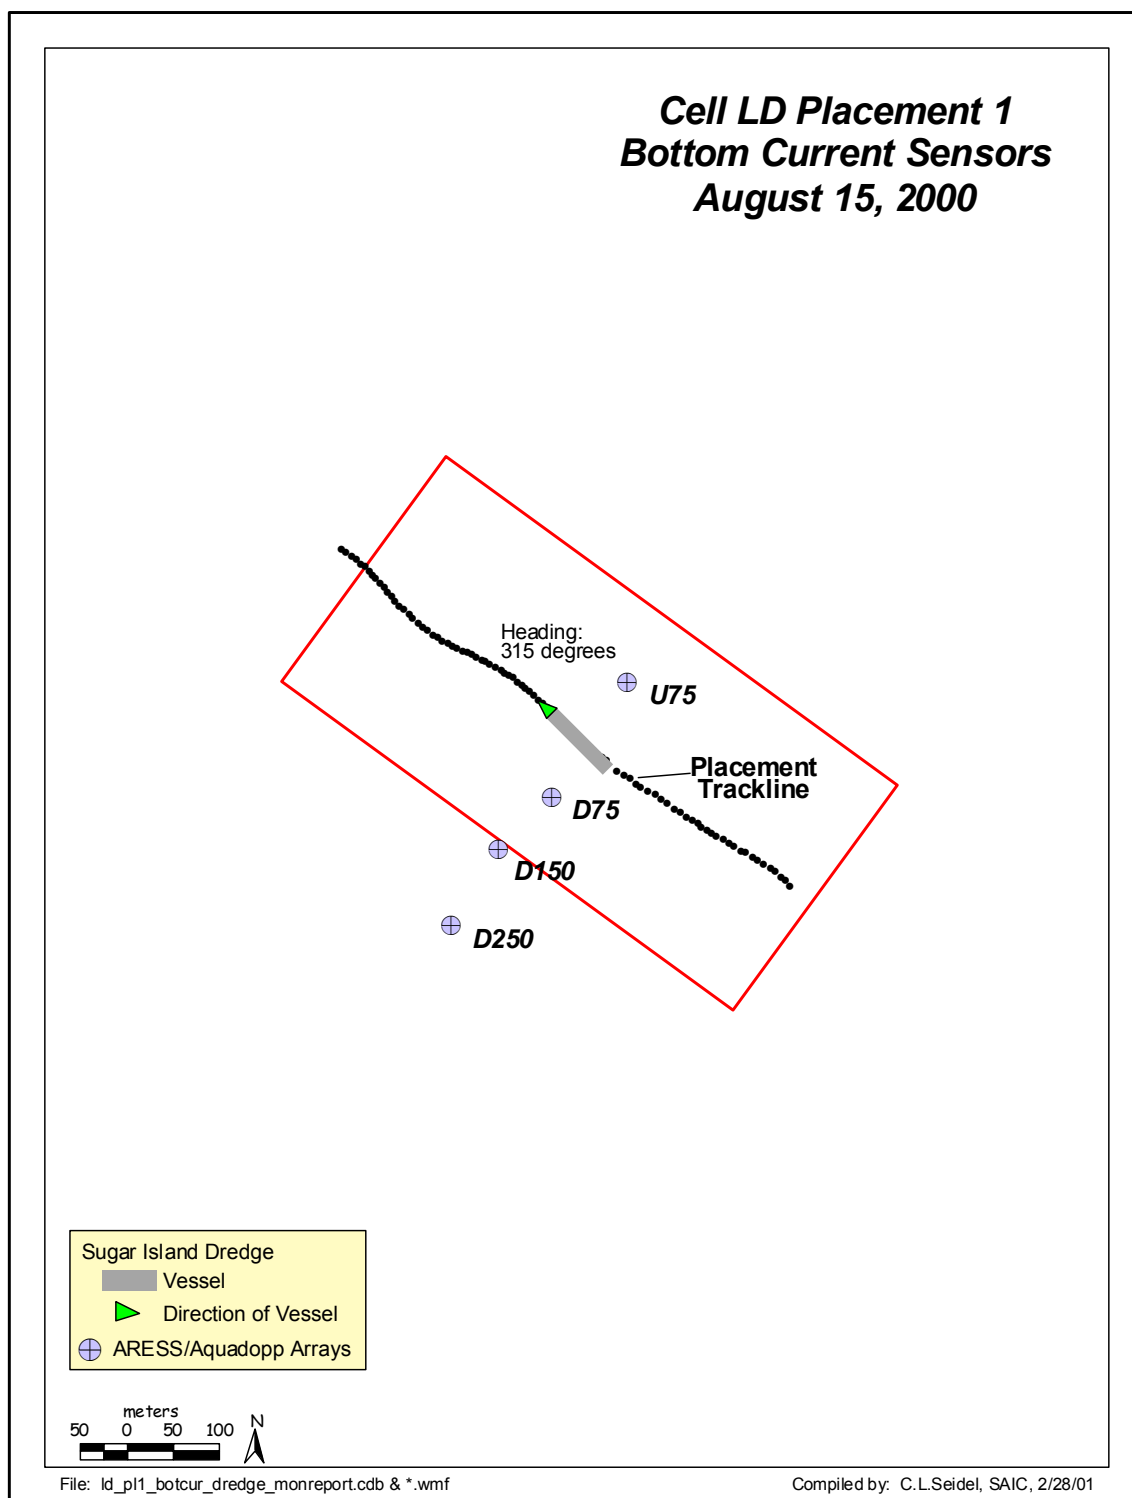
Figure 5.3-1. Map illustrating location of moored instrumentation during placement Event 1 in Cell LD, as well as the trackline of the hopper dredge during the spreading of cap material.

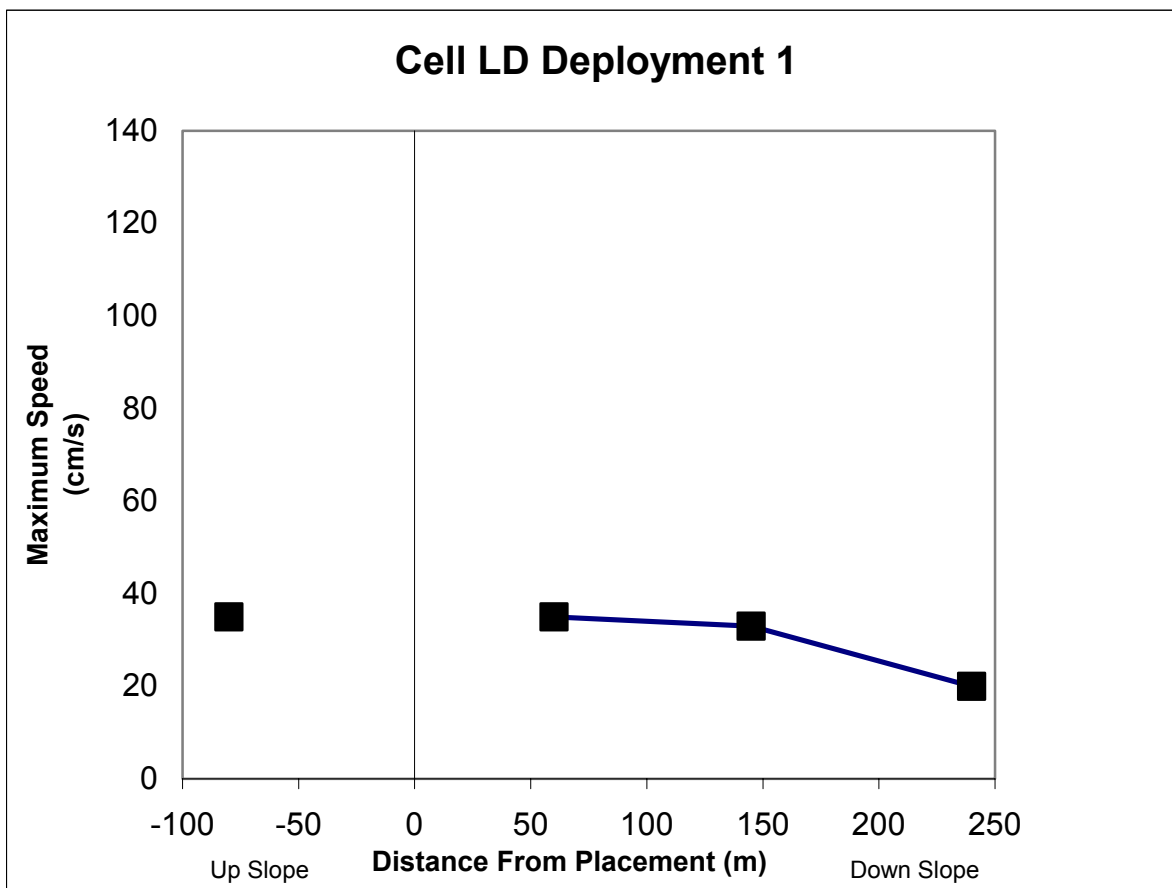
Figure 5.3-5. Plot of the maximum near-bottom current speed (y-axis) observed during cap placement Event 1 at multiple array locations within Cell LD versus the horizontal distance (x-axis) from the moored array locations to the actual cap placement locations (dredge positions).

One of the primary objectives of the surge monitoring effort was to determine whether surge current velocities and turbidity levels decrease with distance from the placement location in Cell LD. Figure 5.3-5 presents a plot of the maximum near-bottom current speed observed at the three downslope and one upslope array locations in Cell LD during placement Event 1 versus the horizontal distance from the moored array location to the actual cap placement location. This figure illustrates that maximum current speeds in the surge were comparable at the 75 m upslope, 75 m downslope and 150 m downslope locations, but the maximum current speeds dissipated somewhat at the 250 m location. What is most noticeable about these surge currents in Cell LD is that they are much less than those observed during all other events monitored in Cells LU and SU (see Figure 4.3-6 and Table 3.3-6 that present a composite of maximum speeds for all cells).

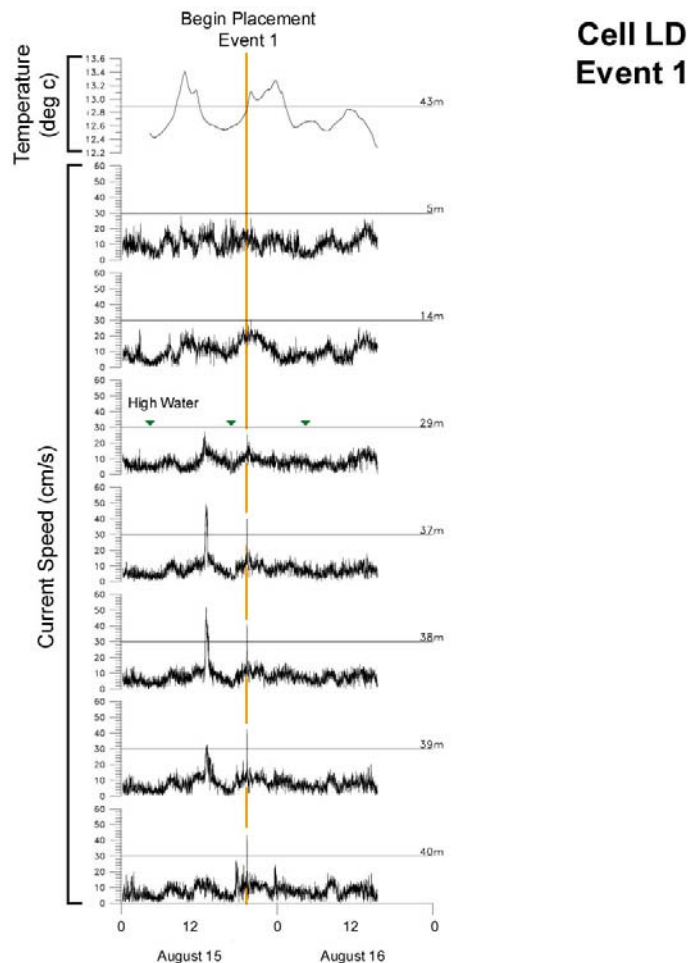
Figure 5.3-6. Time series plot of ADCP data from the 75 m downslope location in Cell LD bracketing cap placement Event 1 from August 15-16, 2000. Water temperature from 1-m above the bottom (top tier). Lower tiers present current speed data from seven 1-m thick depth levels extending from 5 m to 40 m (which was 3 m above the bottom). Data are 1-min averages. The times of high water at the NOAA tide station in Outer Los Angeles Harbor are also shown.

The time series of current speed at the 40-m measurement level (lowest tier in Figure 5.3-6) illustrates weak bottom currents that ranged from 2 to 18 cm/s, with minor fluctuations that occurred at roughly 6-hr intervals. Current speeds did not increase significantly with distance off the bottom up to the 14-m depth level, nor were they much higher at the 5-m level. There was, however, a brief (~1/2 hr) period of relatively high ambient currents observed between the 37-m and 39-m levels at roughly 1300 GMT on August 15. This pulse had very limited vertical extent because it was barely recognizable at the 29-m depth level.

The near-bottom water temperature record from the ADCP (top tier in Figures 5.3-6 and 5.3-7) exhibited temperature fluctuations of approximately 1.0°C at 12-hr periods, with temperature increases occurring during ebb tidal cycles. A small (0.2°C) temperature increase was associated with cap placement Event 1, which was substantially less than temperature increases that had been observed during events in

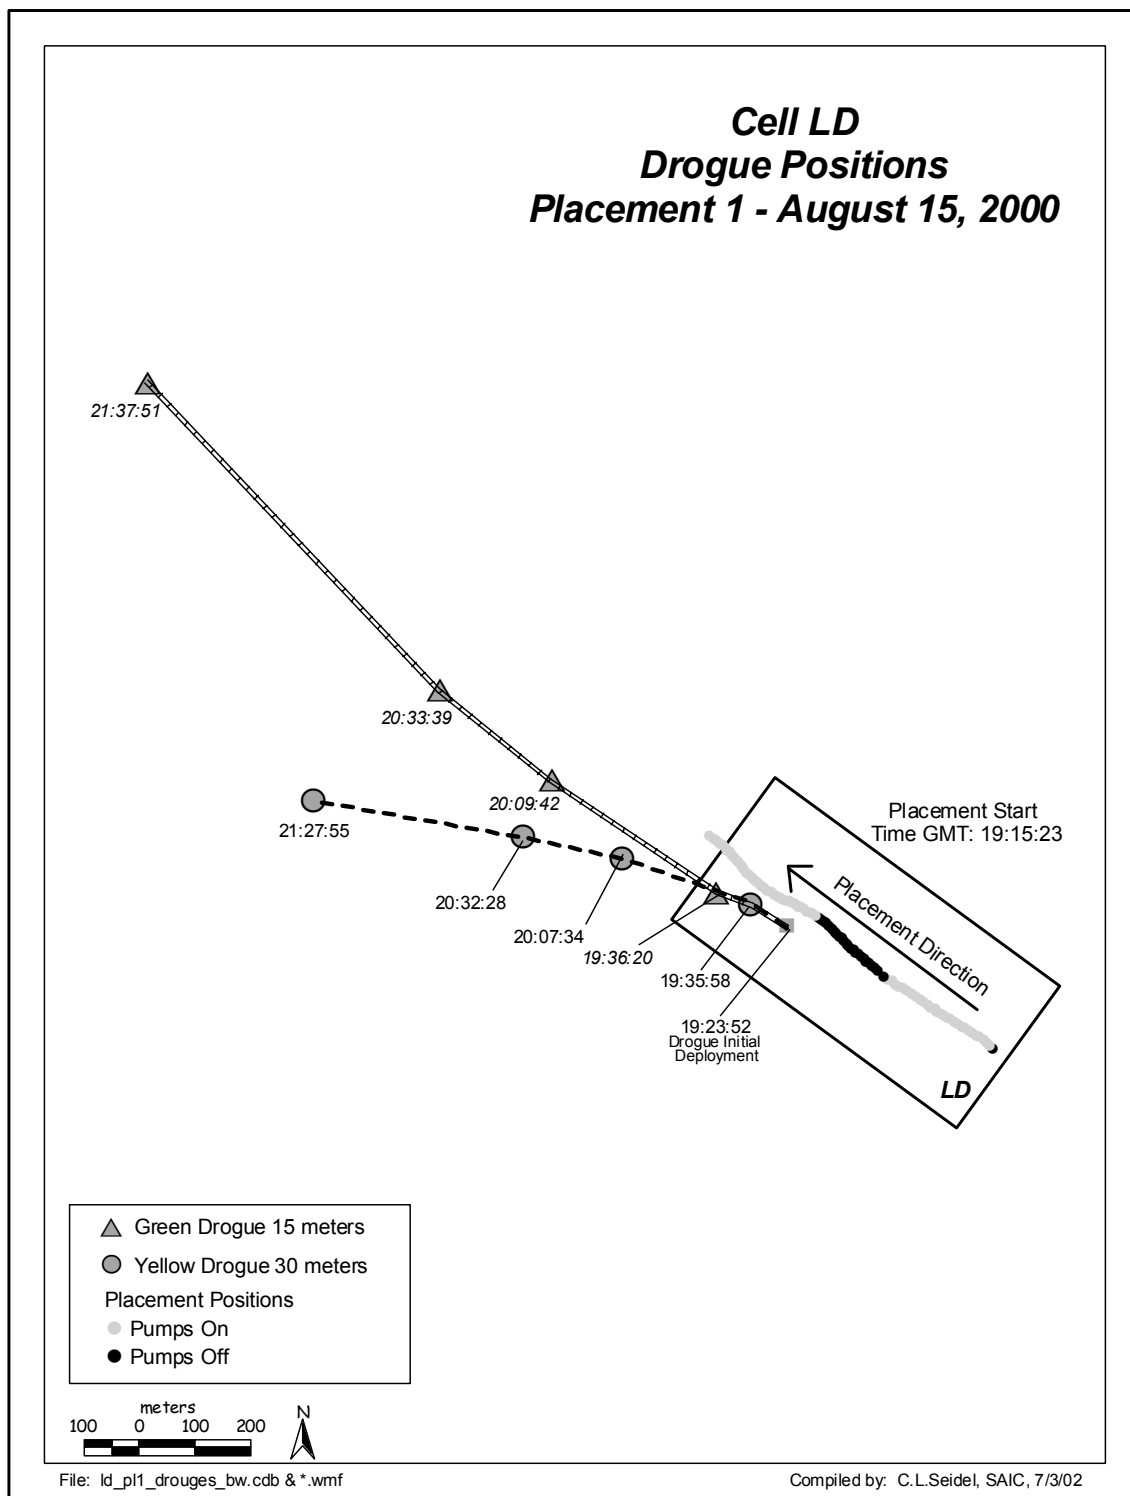
Figure 5.4-1. Map of Cell LD indicating trajectories of two drogues during water quality monitoring of placement Event 1 in Cell LD on August 15, 2000.

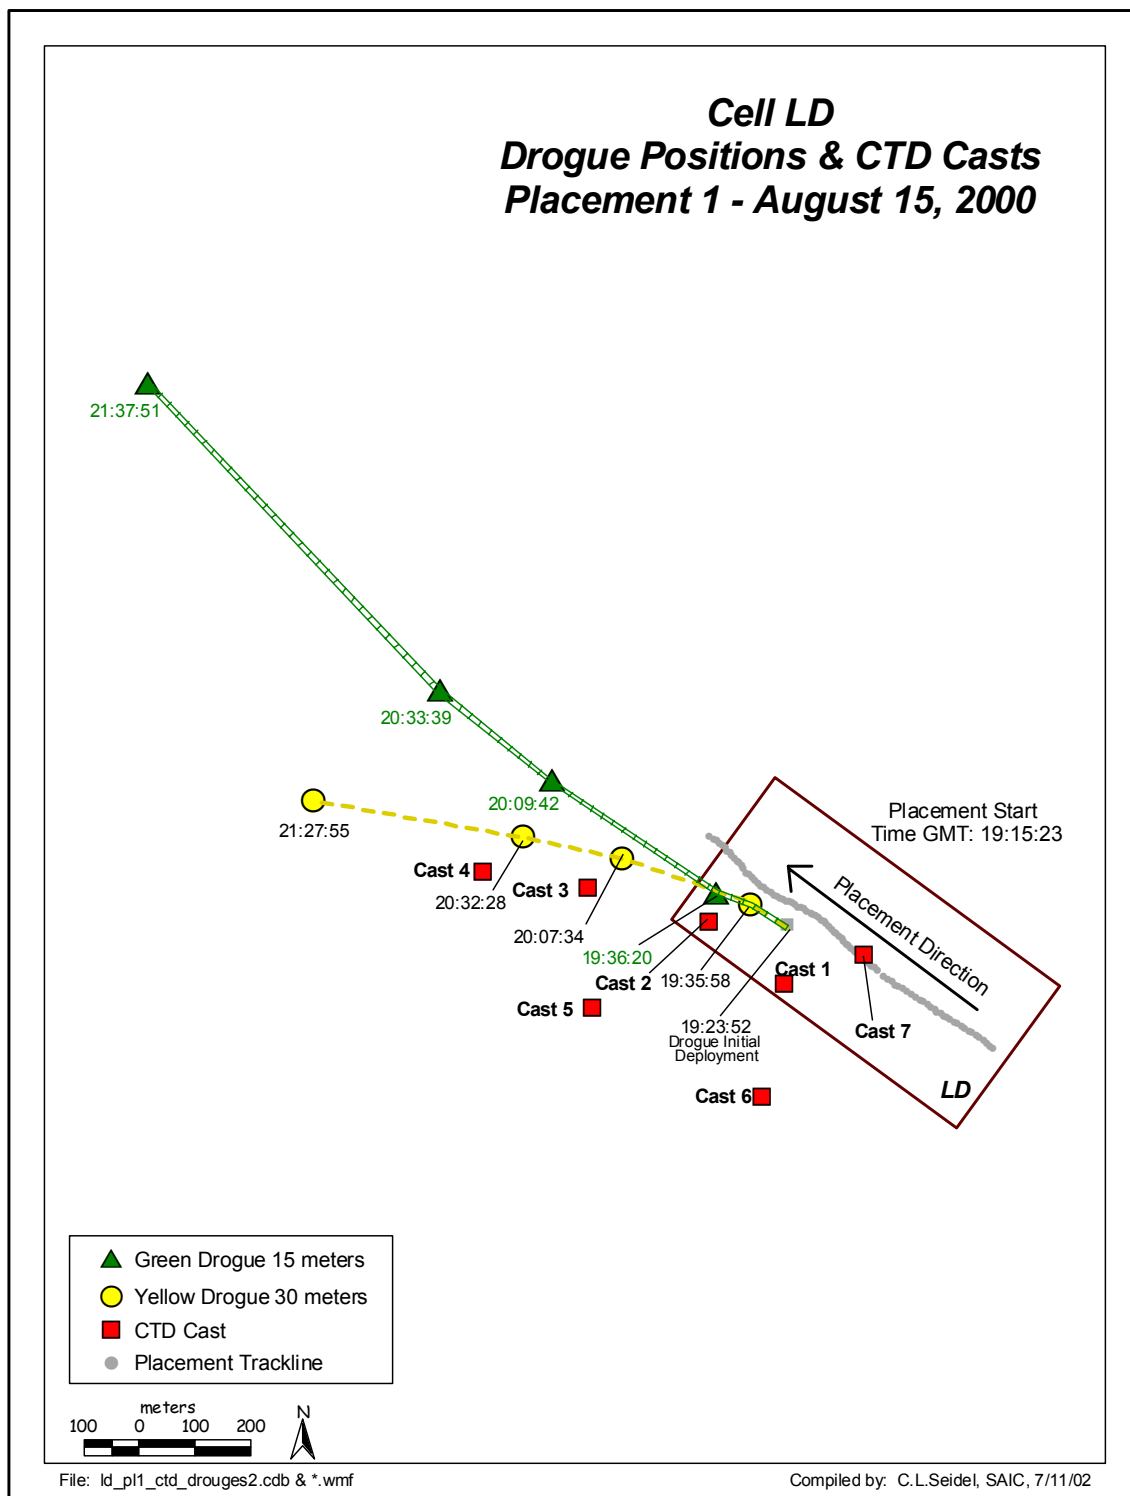
Figure 5.5-1. Map of Cell LD indicating drogue trajectories and CTD stations during cap placement Event 1 on August 15, 2000.

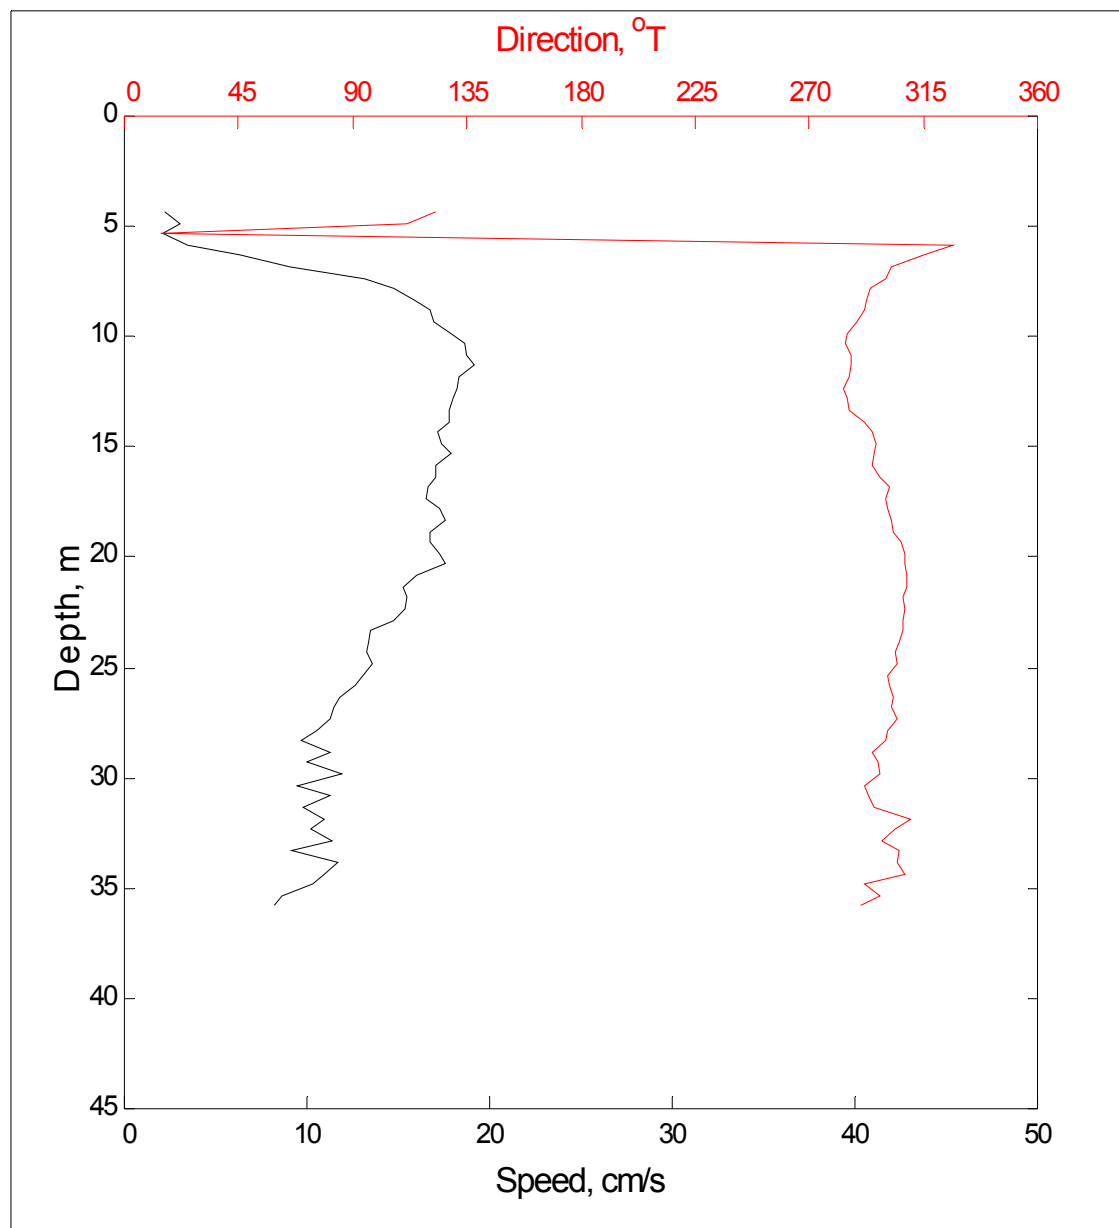
Figure 5.6-1. Vertical current profile on August 15, 2000, at 1830 GMT.

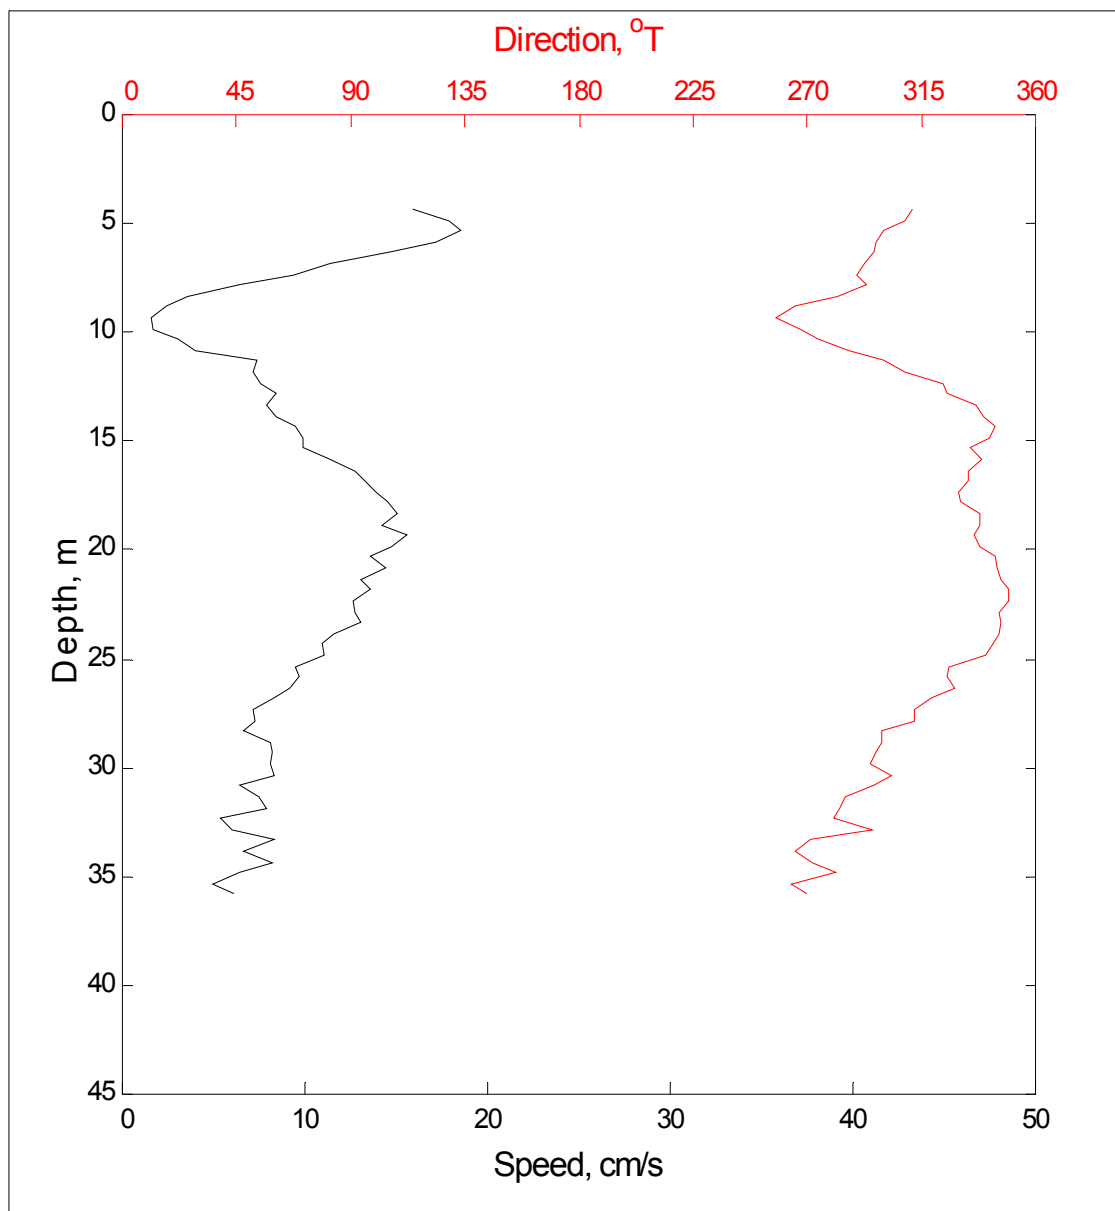
Figure 5.6-2. Vertical current profile on August 15, 2000 at 2208 GMT.

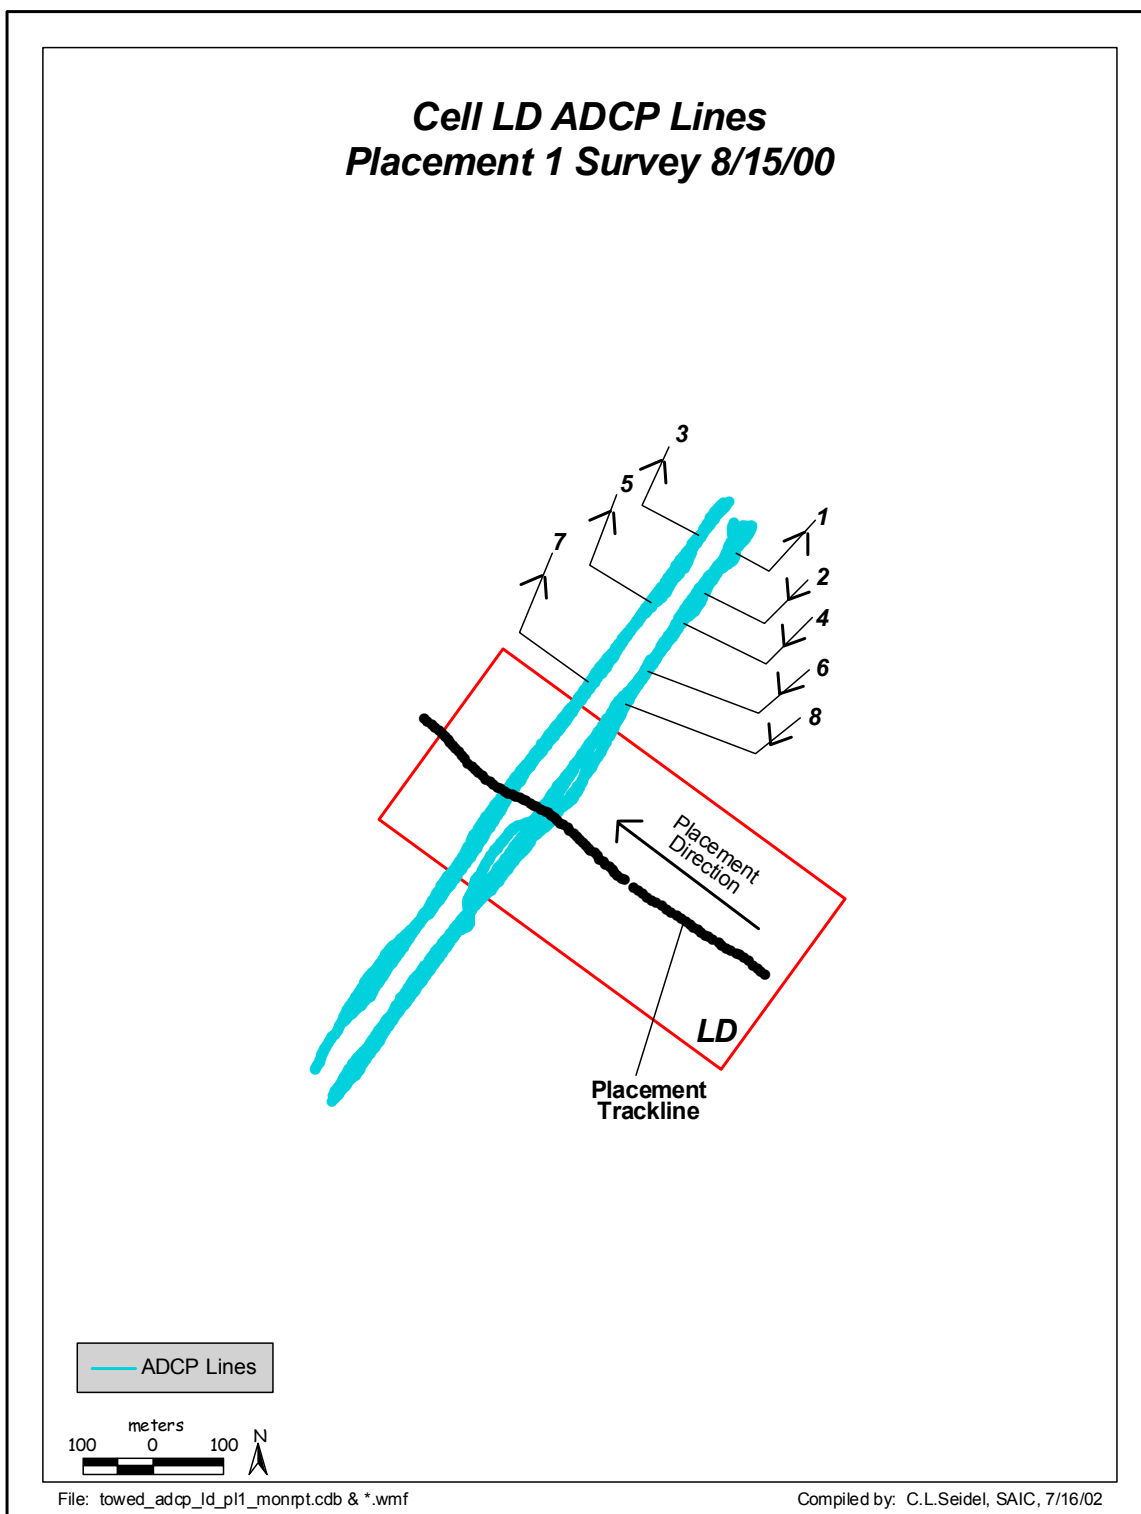
Figure 5.6-3. Survey tracklines for acoustic monitoring of suspended sediment on August 15, 2000.
